DEPARTMENT OF TRANSPORTATION

Office of Structural Materials

Contract #: 04-0120F4Cty: SF/ALA Rte: 80 PM: 13.2/13.9File #: 99.28**WELDING INSPECTION REPORT****Resident Engineer:**Siegenthaler, Peter**Address:** 333 Burma Road**City:** Oakland, CA 94607**Report No:** WIR-022277**Date Inspected:** 25-Mar-2011**Project Name:** SAS Superstructure**OSM Arrival Time:** 700**Prime Contractor:** American Bridge/Fluor Enterprises, a JV**OSM Departure Time:** 1900**Contractor:** Zhenhua Port Machinery Company, Ltd (ZPMC), Changxing Island **Location:** Shanghai

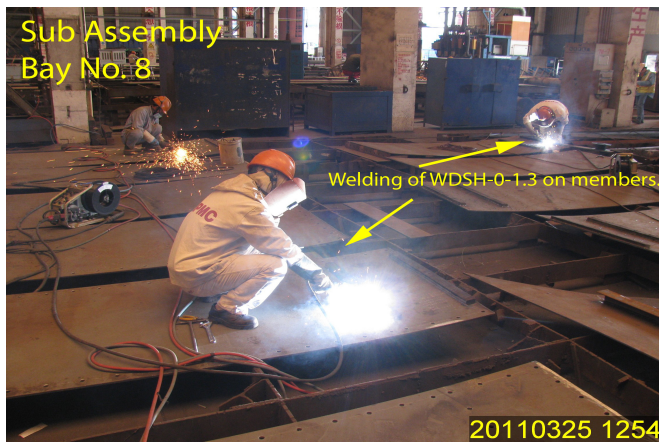
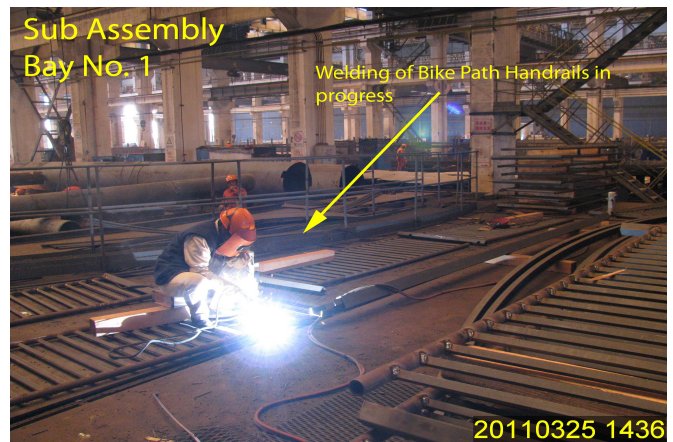
Unless otherwise noted above all items observed on this day appeared to be in general compliance with the applicable contract documents
